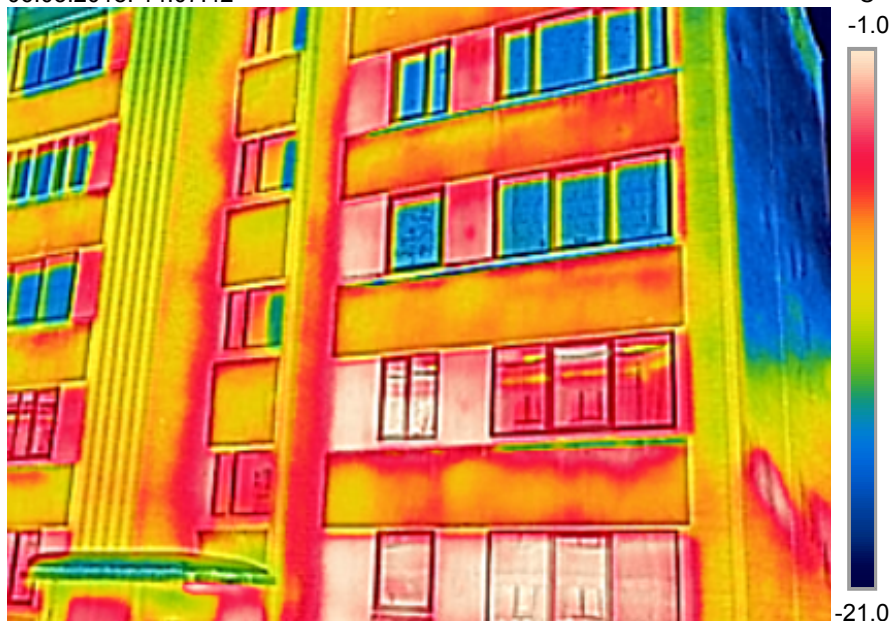
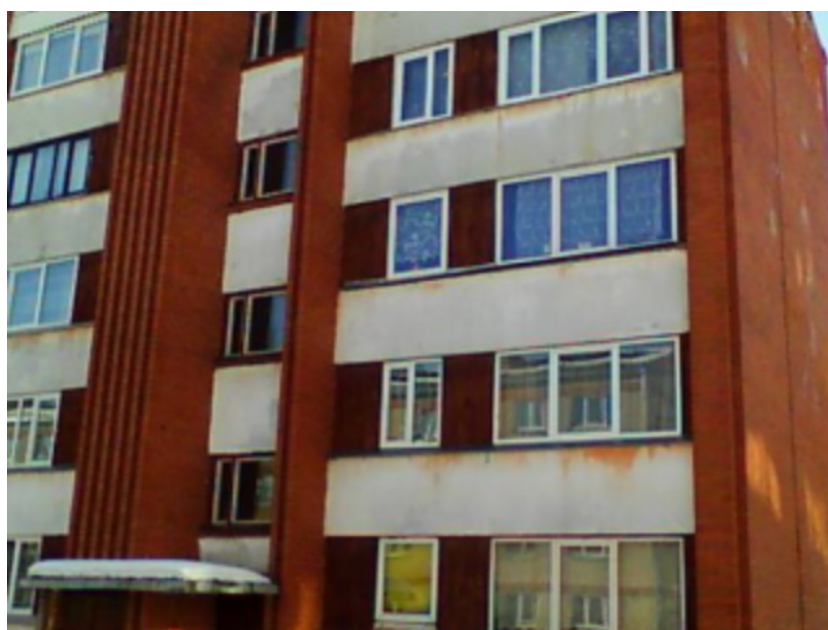
FLIR1662.jpg

Ēkas termogramma.

Siltuma zudumi caur norobežojošām konstrukcijām, būvelementu termiskie tilti.

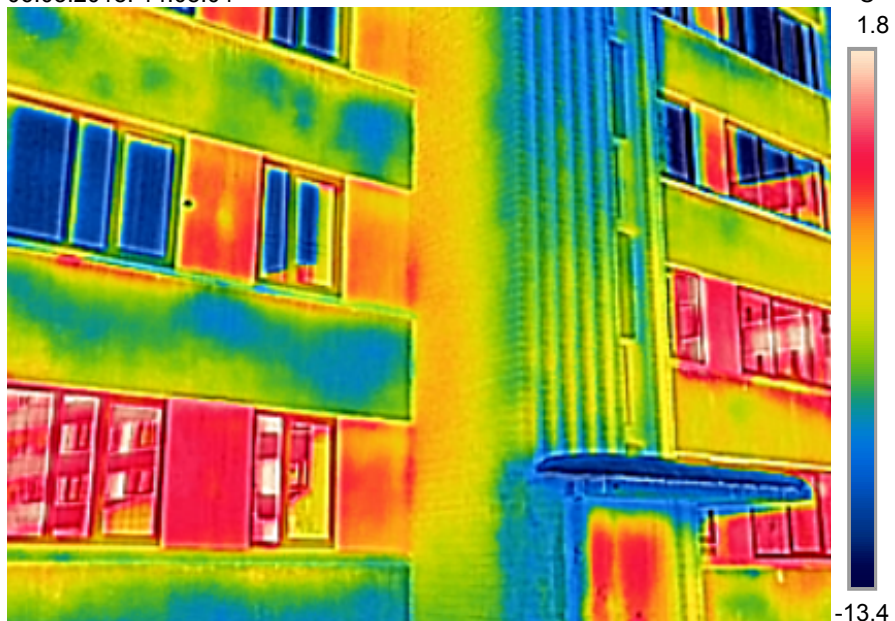
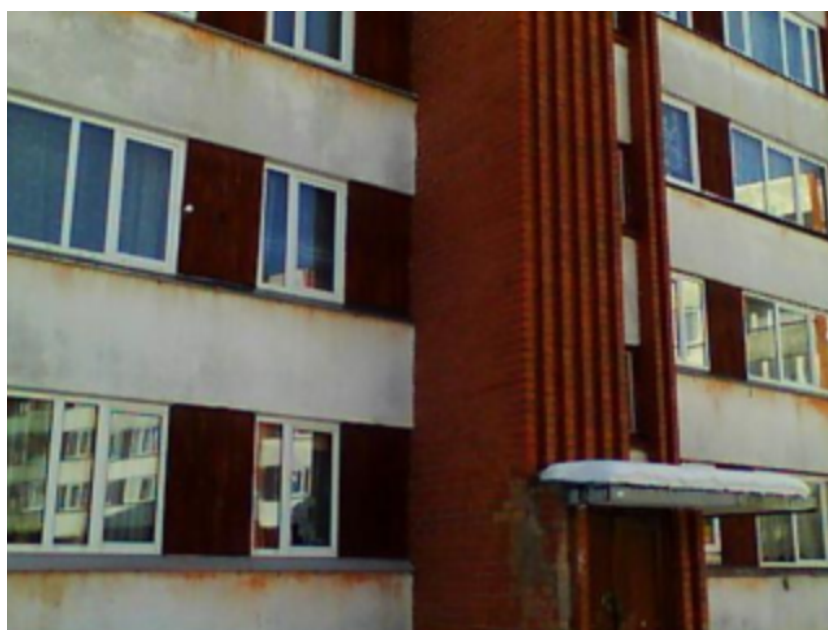
FLIR1666.jpg

Ēkas termogramma.

Siltuma zudumi caur norobežojošām konstrukcijām, būvelementu termiskie tilti.

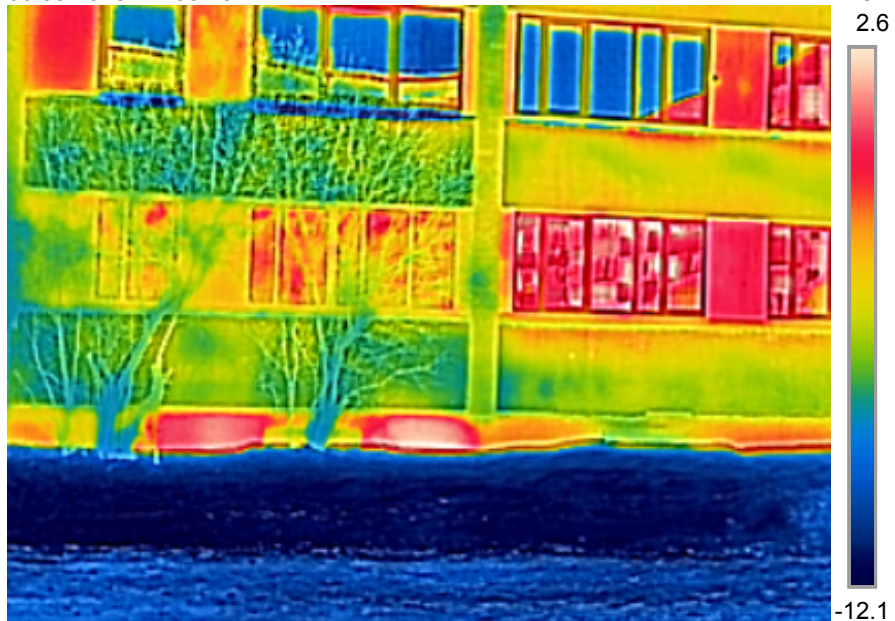
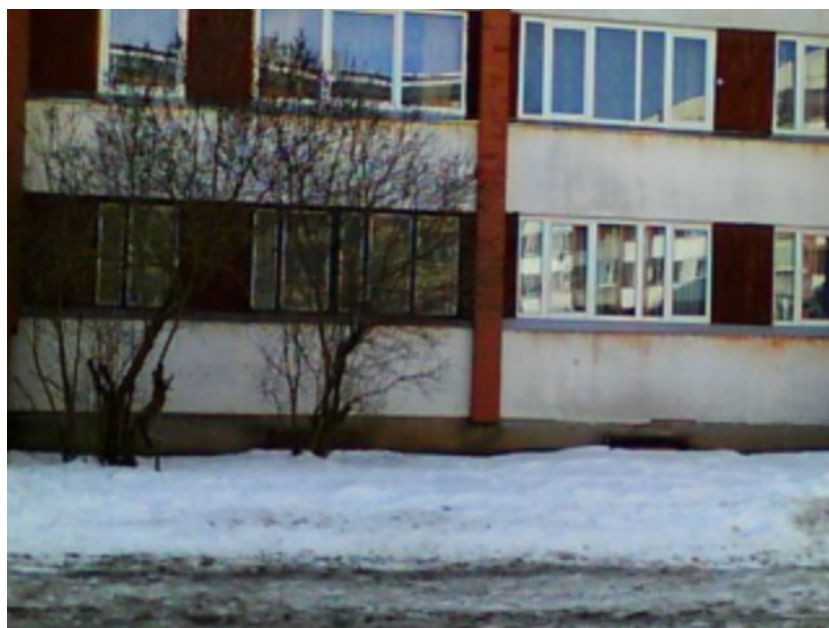
FLIR1670.jpg

Ēkas termogramma.

Siltuma zudumi caur norobežojošām konstrukcijām, būvelementu termiskie tilti.

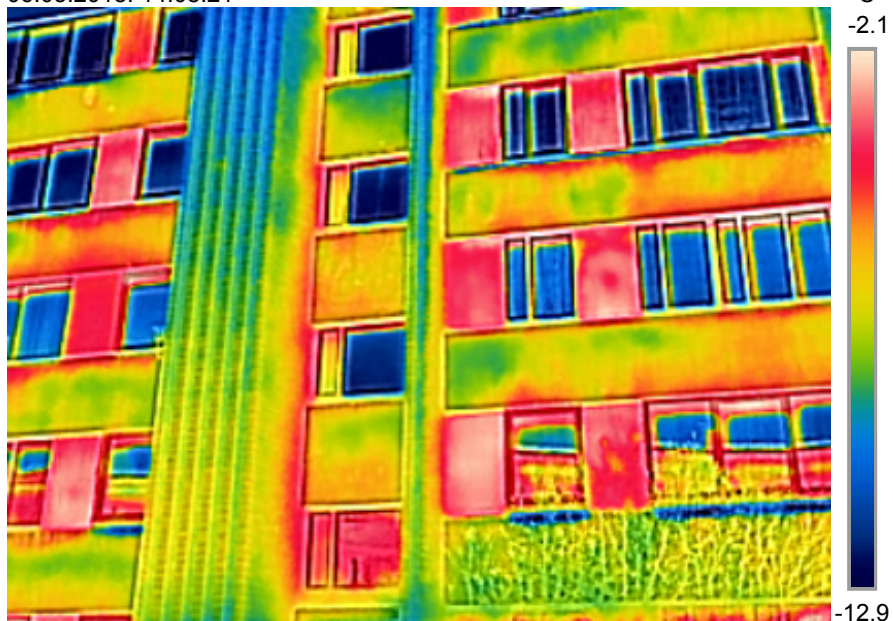
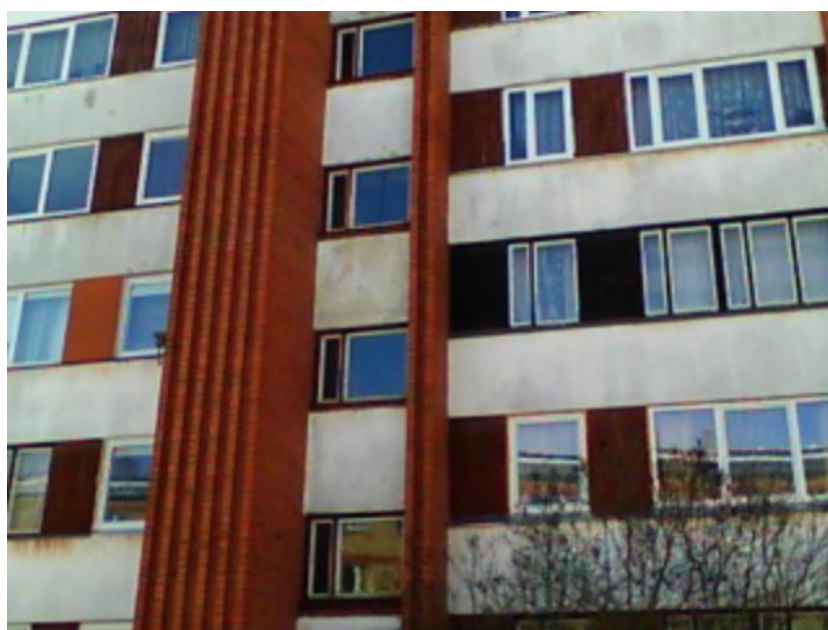
FLIR1672.jpg

Ēkas termogramma.

Siltuma zudumi caur norobežojošām konstrukcijām, būvelementu termiskie tilti.

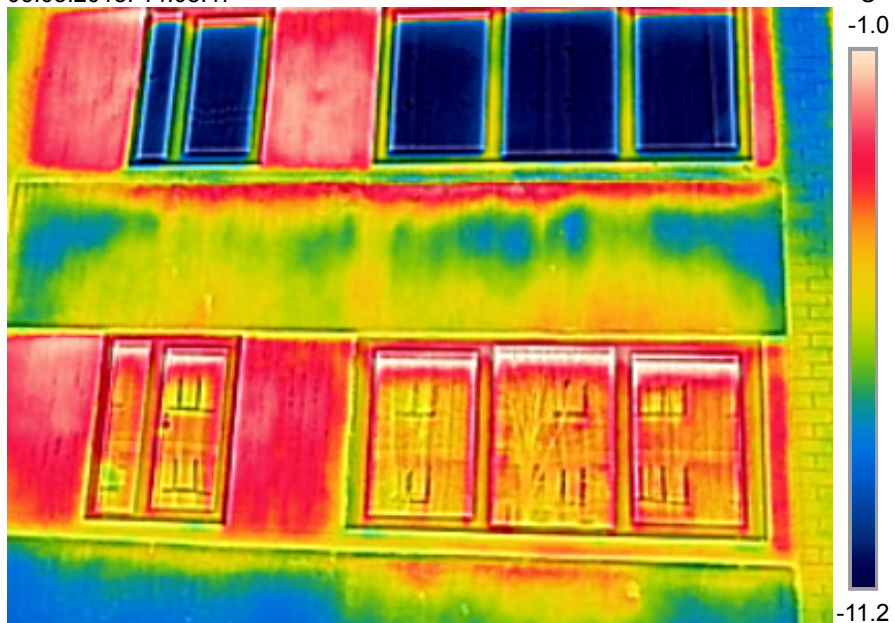
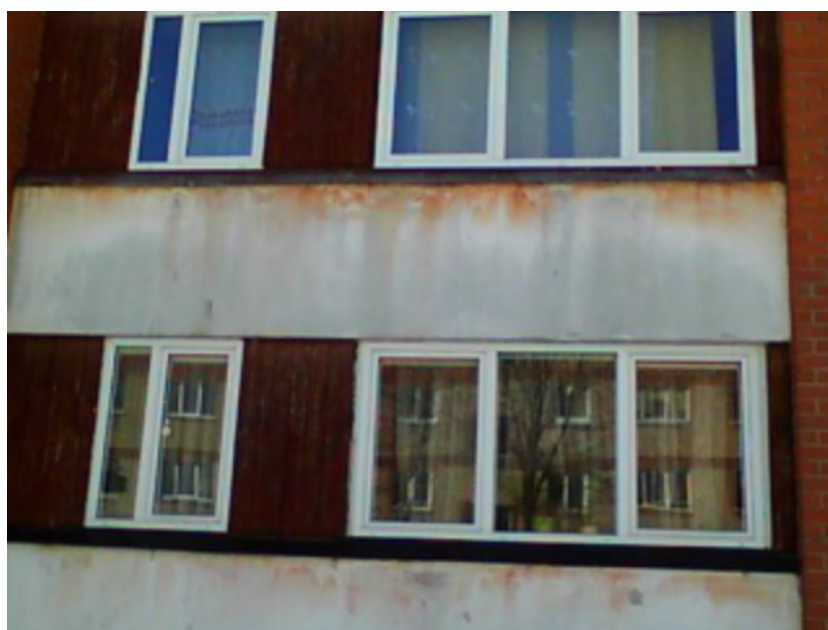
FLIR1678.jpg

Ēkas termogramma.

Siltuma zudumi caur norobežojošām konstrukcijām, būvelementu termiskie tilti.

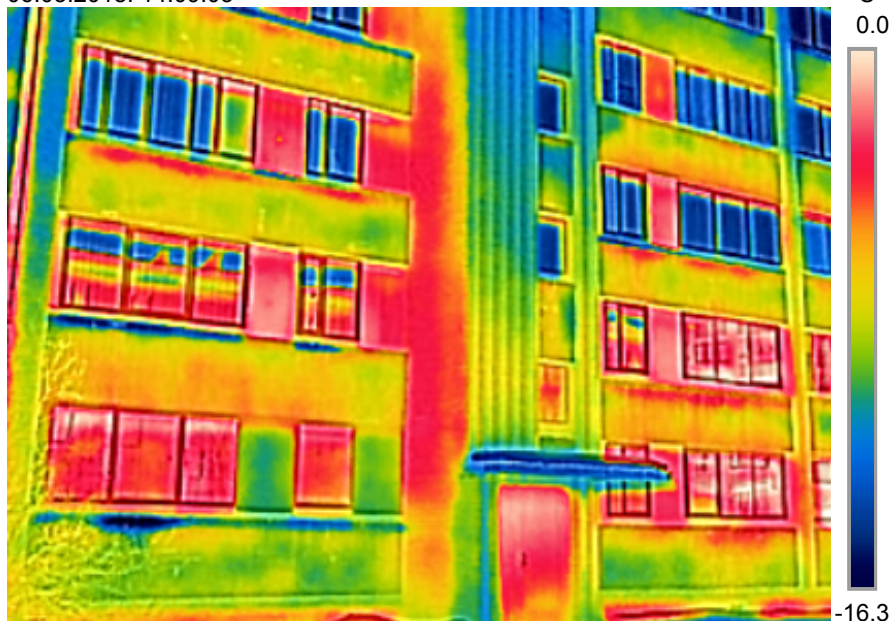
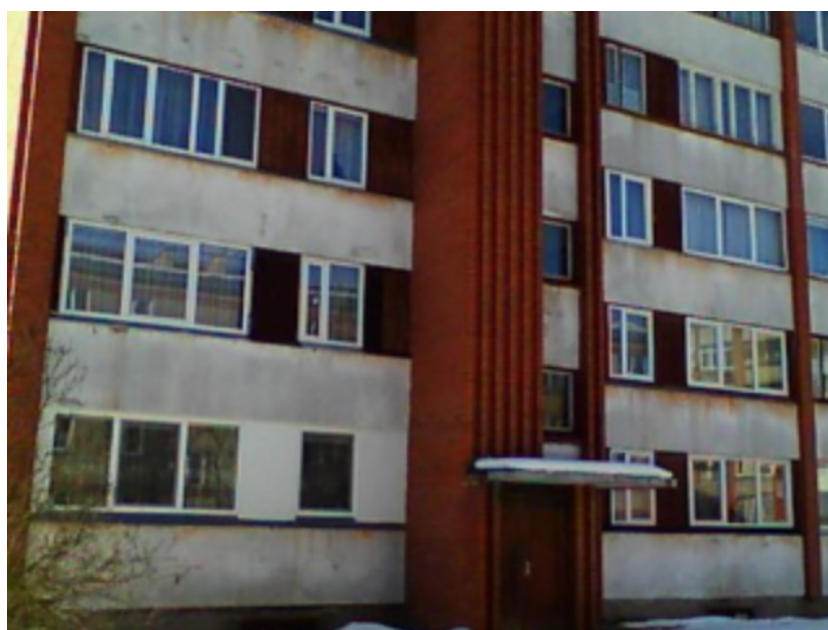
FLIR1680.jpg

Ēkas termogramma.

Siltuma zudumi caur norobežojošām konstrukcijām, būvelementu termiskie tilti.
